**NPDES
Inspection Report**

**Anchorage Fueling and Service Company
Operations and Maintenance Base
(NPDES Permit #: AKR06AC95)**

Anchorage, Alaska

May 24 and 25, 2017

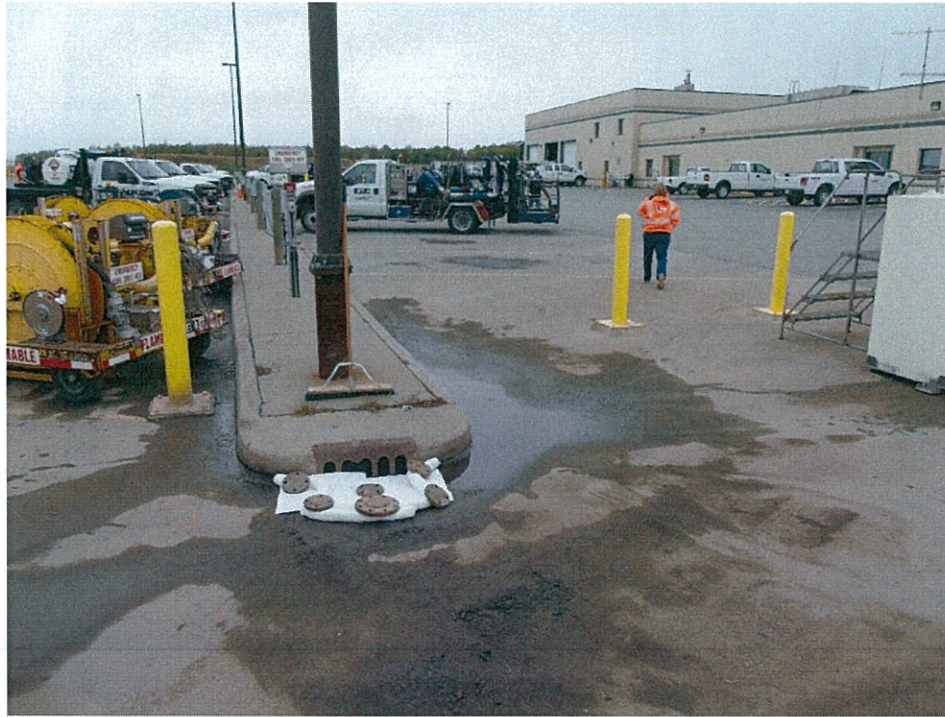
Photo #1: Westerly view showing the storm drain located on the east side of the hydrant truck parking area (at the O&M Base). Note the facility office building on the upper right. Stormwater entering this drain is routed through an oil/water separator before leaving the facility. Camera photograph #DSC05523.JPG.

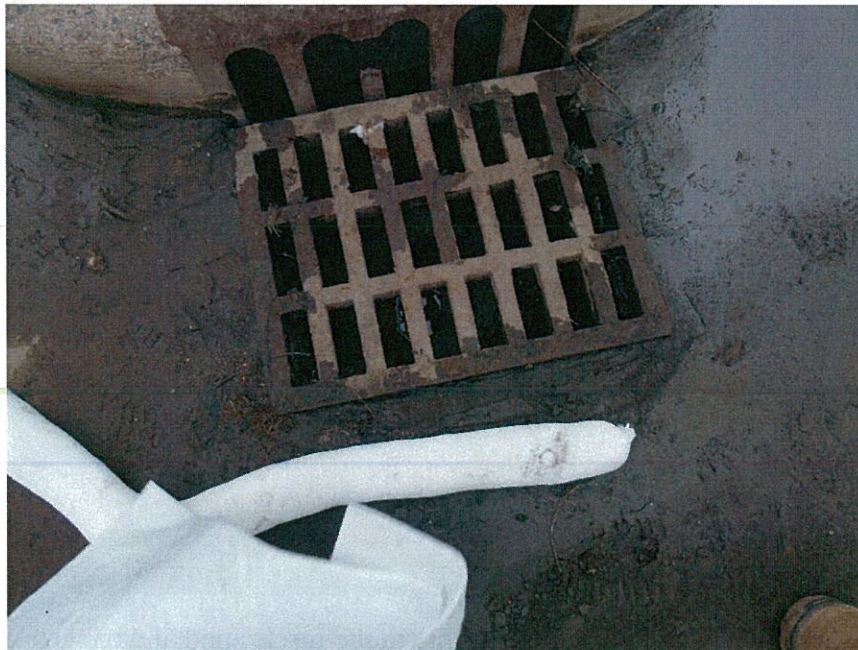
Photo #2: Closeup of the storm drain shown in the previous photograph. Camera photograph #DSC05524.JPG.

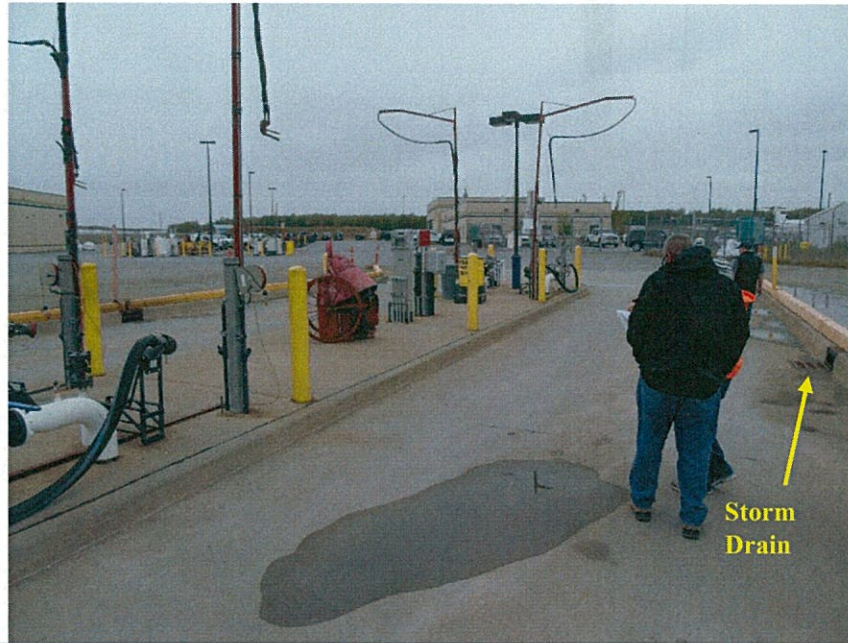
Photo #3: Westerly view showing the area of the fuel loading rack (at the O&M Base). Note the storm drain on the right side of the photograph and the office building in the background. Stormwater collected in the vicinity of the loading rack is routed through an oil/water separator before leaving the facility. Camera photograph DSC05527.JPG.

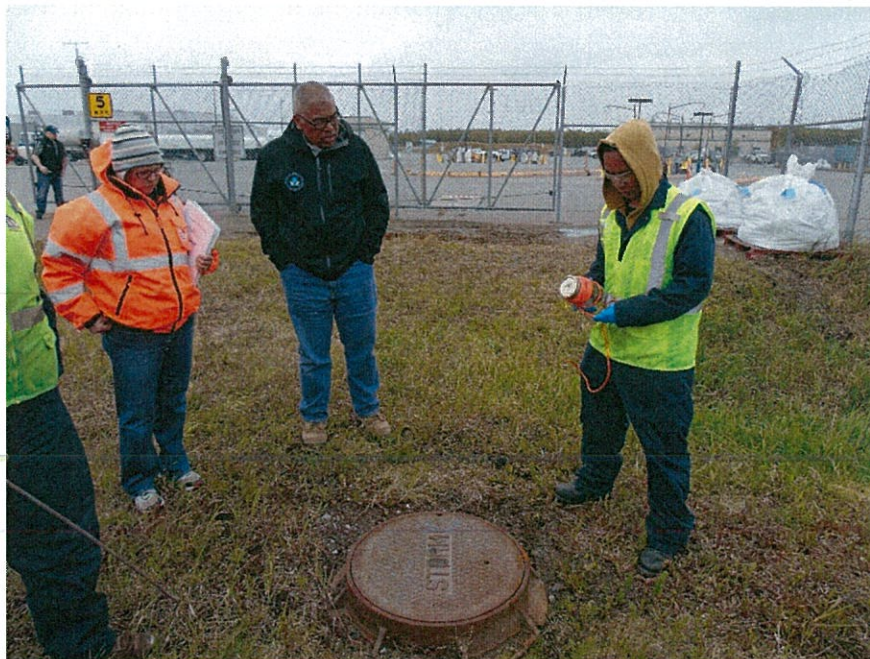
Photo #4: Westerly view showing the manhole in the foreground and the O&M Base in the background. This manhole is the visual assessment sample collection point for the facility. All stormwater collected at the facility is routed through this manhole before leaving the facility. Camera photograph #DSC05525.JPG.

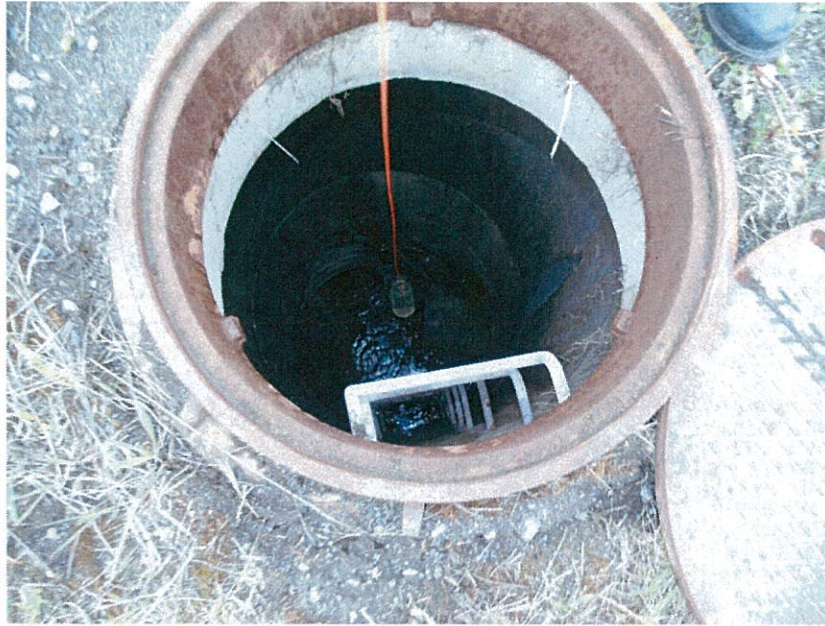
Photo #5: View inside the manhole shown in the previous photograph. Facility representatives demonstrated how visual assessment samples are collected from this manhole at the time this photograph was taken. Camera photograph #DSC05526.JPG.

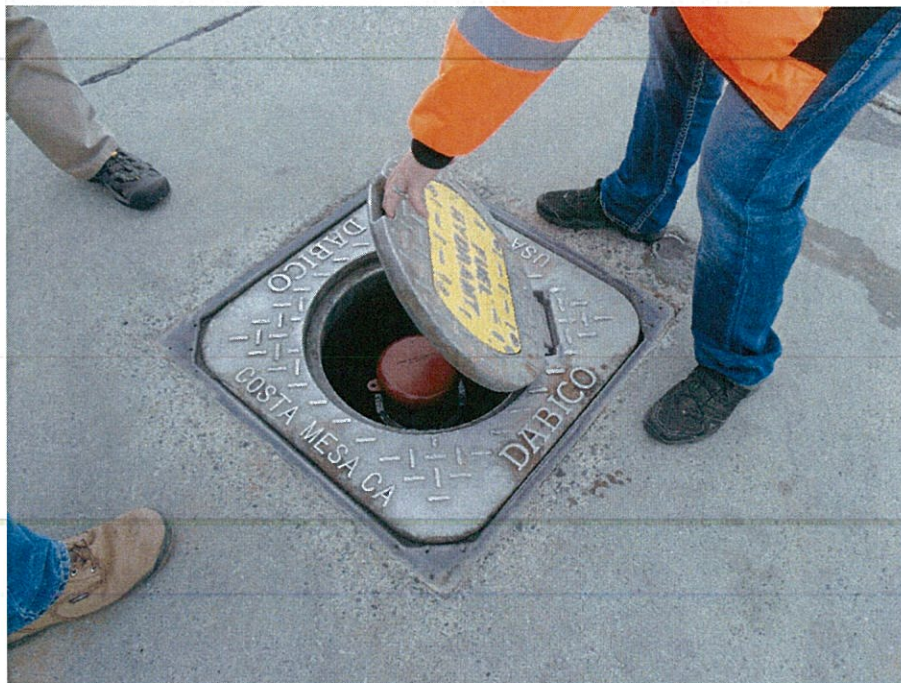
Photo #6: View of one of the hydrant fueling pits located on the airport tarmac. Hydrant trucks operated by ASIG connect to these hydrant fueling pits in order to fuel airplanes. Although this location is outside of the O&M Base property boundary, it is included as part of this photograph log because the usual practice of the facility is to enter the airport tarmac to fuel aircraft. Camera photograph #DSC05519.JPG.

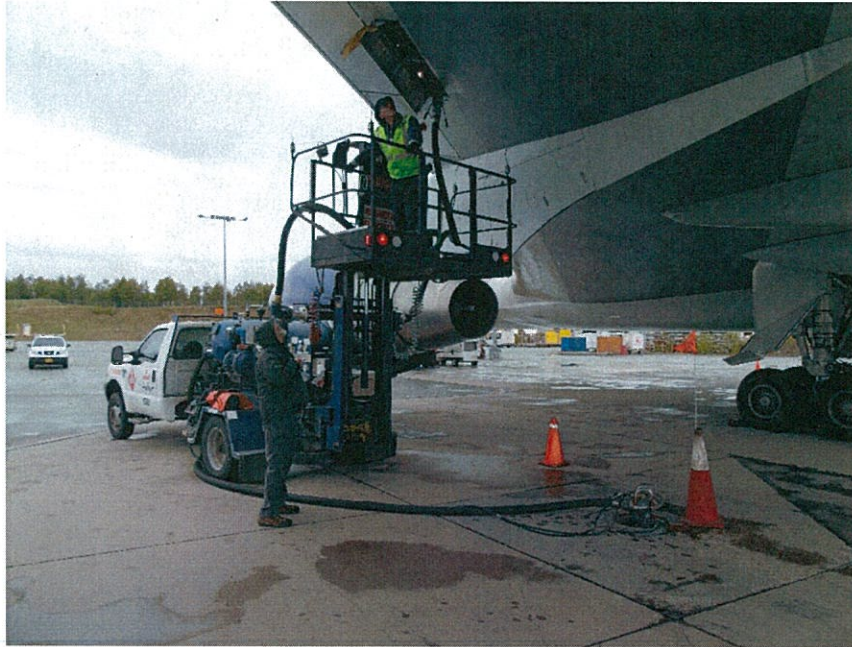
Photo #7: View of a hydrant truck connected to a hydrant pit in the process of fueling a plane. Although this location is outside of the O&M Base property boundary, it is included as part of this photograph log because the usual practice of the facility is to enter the airport tarmac to fuel aircraft. Camera photograph #DSC05521.JPG.

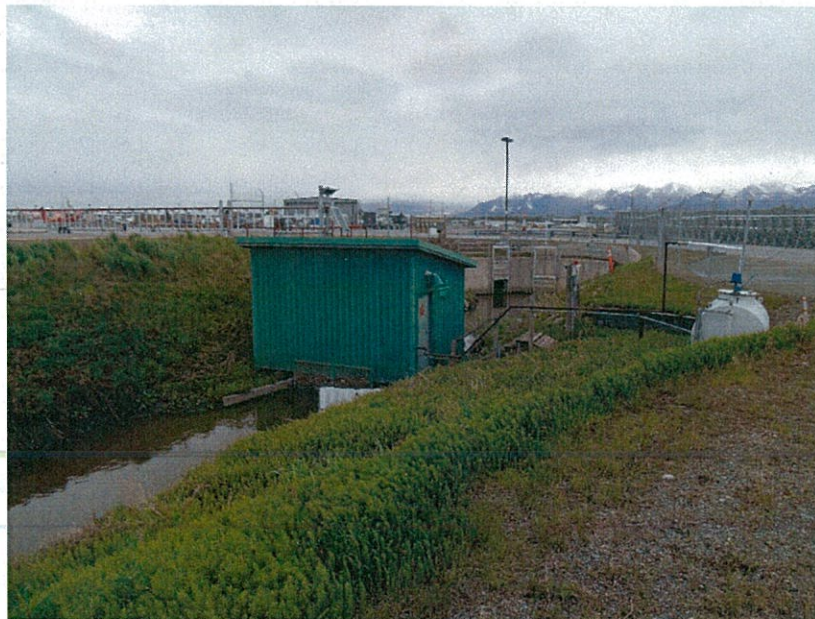
Photo #8: View of one of the drainage channels that routes stormwater away from the airport property. This particular channel routes stormwater through the outfall identified as outfall D. Note that this drainage channel is managed by the Anchorage International Airport and that multiple airport tenants discharge through this channel. Camera photograph #DSC05520.JPG.

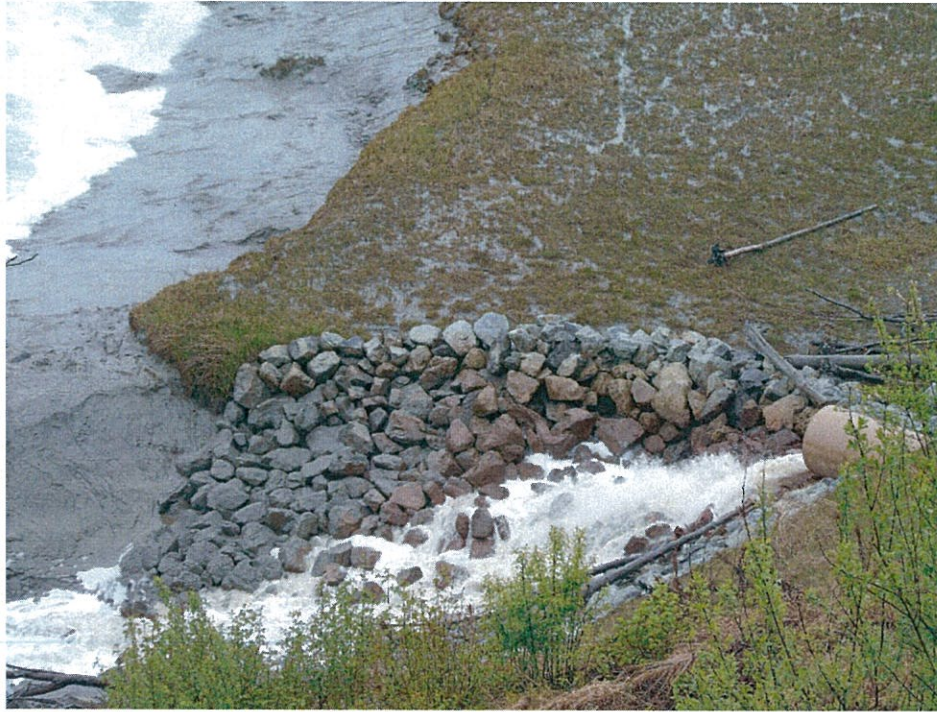
Note, however, that this facility is one of multiple airport tenants that discharges stormwater through one of the five outfalls managed by the AIA. Also note that the airport does conduct benchmark sampling at each of these five stormwater outfalls. The benchmark sampling conducted since the third quarter of 2013 indicates that benchmark values for BOD, COD and pH have been exceeded by the airport (as a whole) on numerous occasions. I did not obtain adequate information at the time of the inspection, however, to determine whether these benchmark exceedances can be attributed, in whole or in part, to the O&M Base. Additional investigation is necessary in order to make this determination.

Photo #9: View of outfall D from the Anchorage International Airport entering the Knik Arm Cook Inlet. Note the foam in the discharge. Camera photograph #DSC05515.JPG.

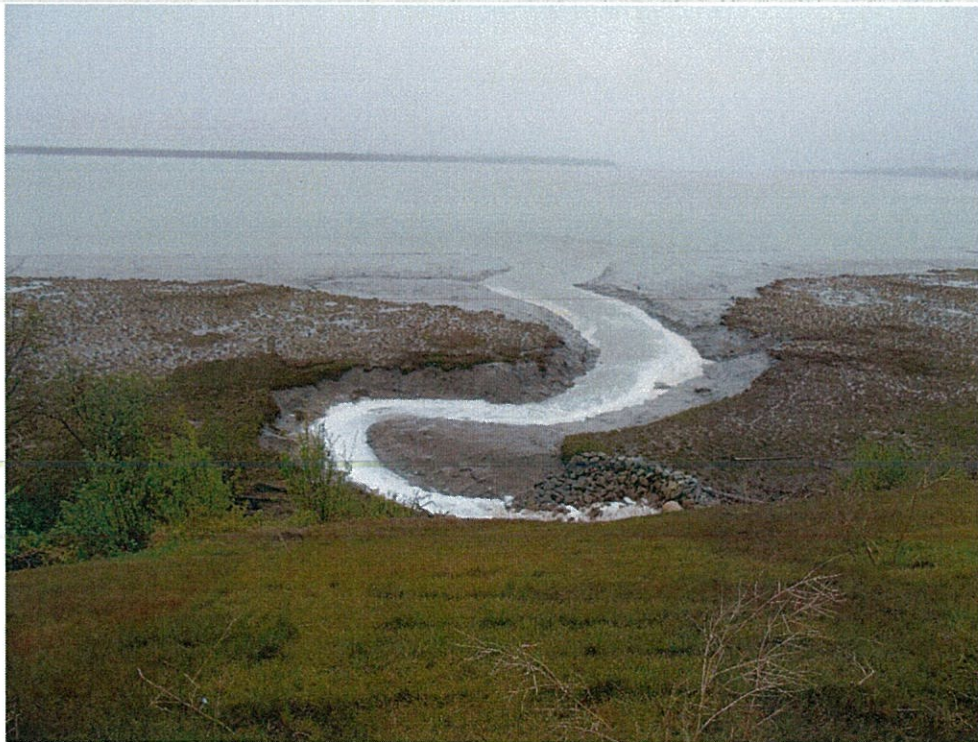
Photo #10: Another view of outfall D from the Anchorage International Airport entering the Knik Arm Cook Inlet. Note the foam in the discharge. Camera photograph #DSC05516.JPG.
